PASTIN HOME INSPECTIONS, L.L.C.

INTERNACHI RESIDENTIAL

60 Mt Lebanon Blvd
Pittsburgh, PA 15228

Pamela Countouris
APRIL 27, 2022

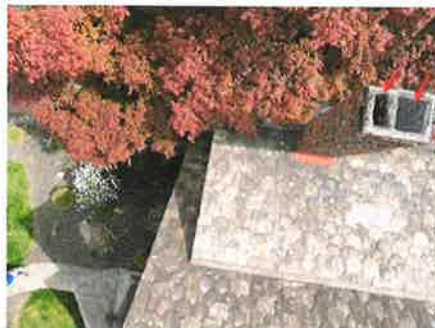
Chimney

CHIMNEY CAP MISSING

CHIMNEY

No chimney cap was observed. This is important to protect from moisture intrusion and protect the chimney. Recommend a qualified roofer or chimney expert install.

Contact a qualified roofing professional.

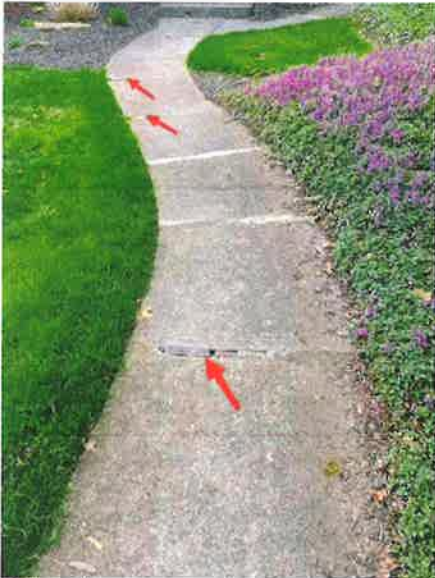
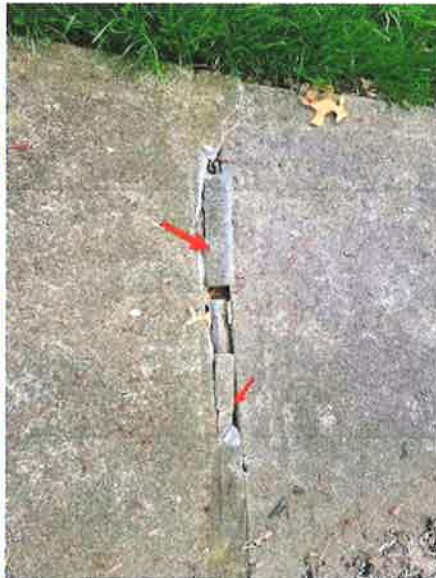
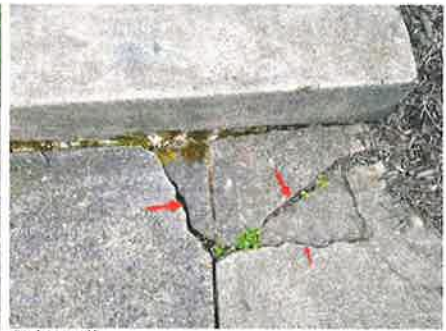
Sidewalk

WALKWAY CRACKING - MINOR

FRONT SIDEWALK

Minor cracking of the concrete front sidewalk. There some loose concrete repair work along the sidewalk and there was some cracking and settling right of the front steps. Recommend monitor and/or patch/seal.

Contact a qualified professional.

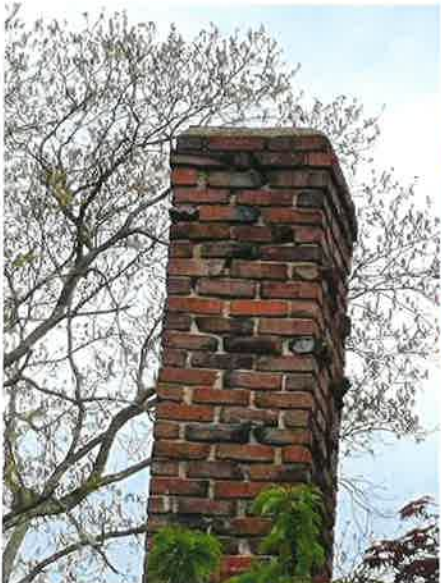
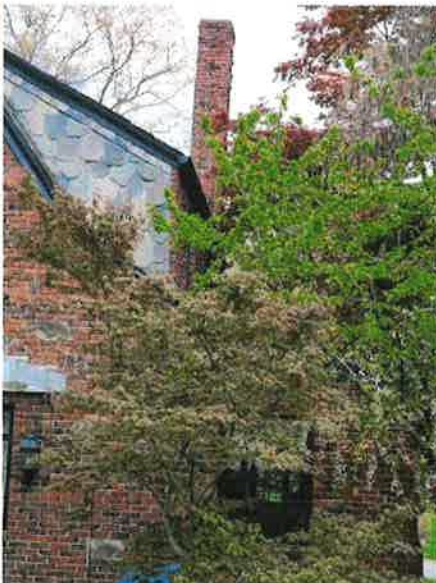
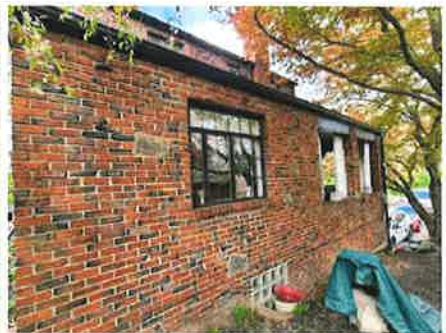
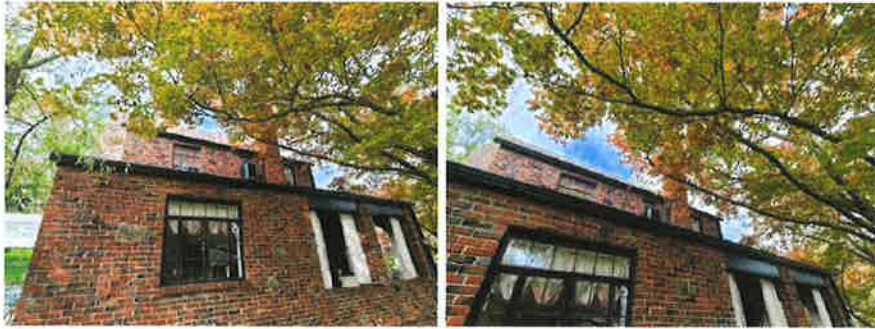
TREE OVERHANG

LEFT FRONT SIDE & REAR LEFT CORNER

Trees observed overhanging the roof along the front left side and rear left corner of the house. This can cause damage to the roof and prevent proper drainage. Recommend a qualified tree service trim to allow for proper drainage.

Contact a qualified tree service company.

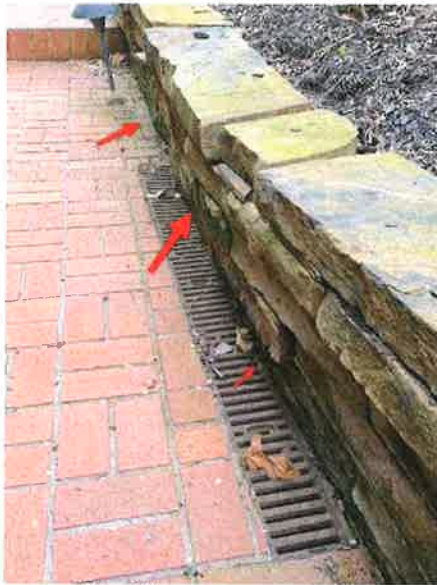
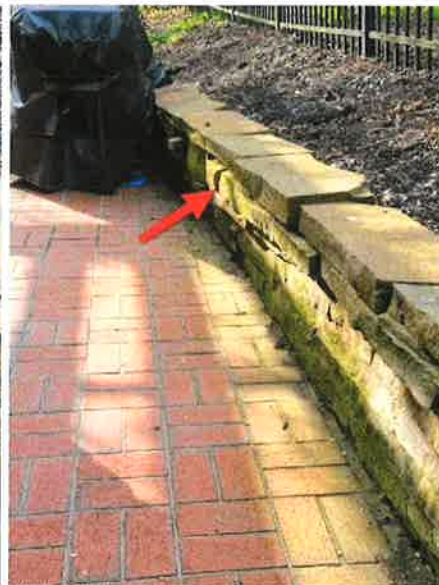
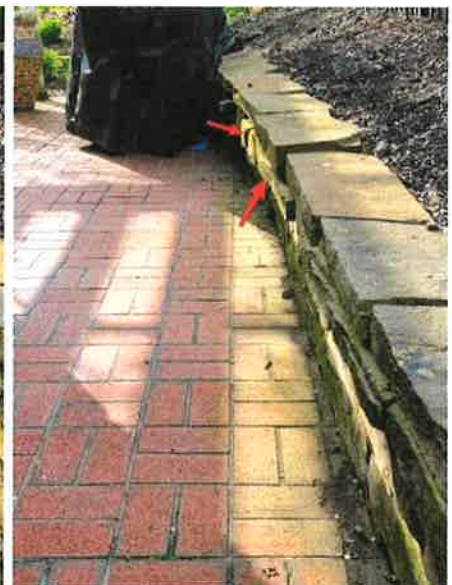
Right side of House

RETAINING WALL MOVEMENT

RIGHT SIDE OF HOUSE

The retaining wall along the right side of the house is showing signs of movement and beginning to lean towards the sidewalk.

Recommend a qualified contractor restack the stone wall where needed.

Contact a qualified professional.

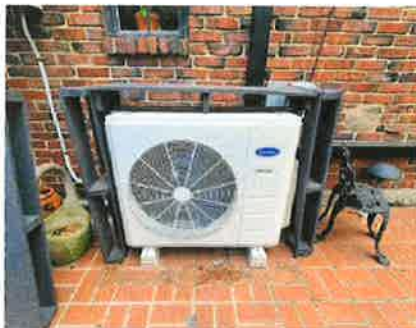
Carrier Split Unit - December 2020

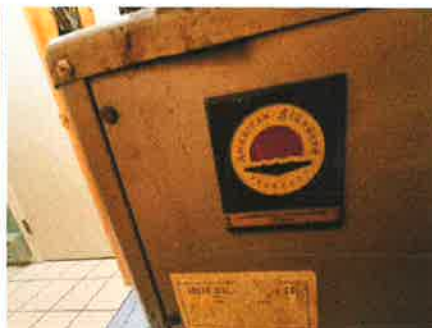
American Standard Boiler - MFG Date Undetermined

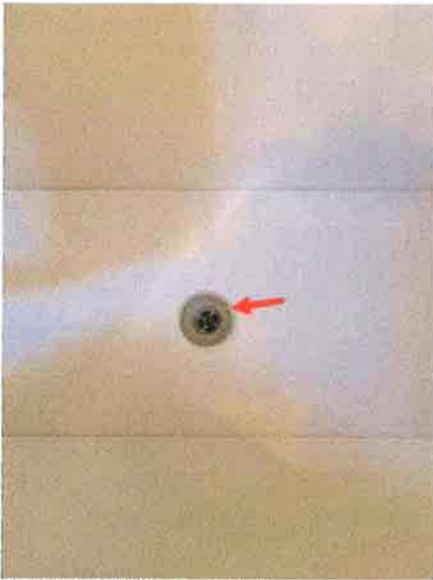
2nd Floor Bathroom Tub

MISSING DRAIN STOPPER

The 2nd floor hallway bathroom is missing a tub drain stopper and 1st floor bathroom is also missing a sink drain stopper.

Recommend a plumbing contractor install new drain stoppers in the bathroom tub and bathroom sink.

Contact a qualified plumbing contractor.

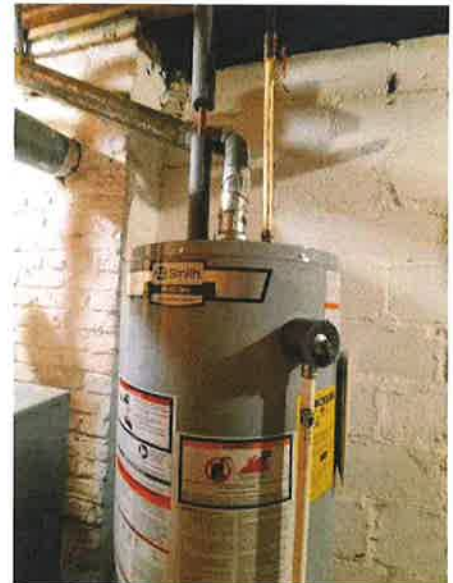
Basement

NO EXPANSION TANK

BASEMENT FURNACE ROOM

No expansion tank was present. Expansion tanks allow for the thermal expansion of water in the pipes. These are required in certain areas for new installs. Recommend a qualified plumber evaluate and install.

Contact a qualified plumbing contractor.

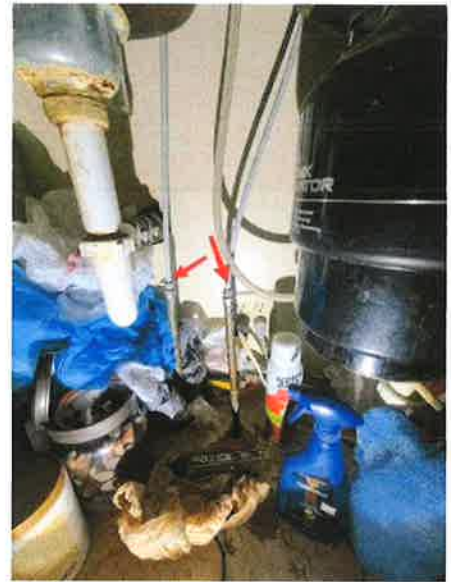
Kitchen

MISSING SHUT OFF VALVES

KITCHEN

There were no hot or cold water shut off valves under the kitchen sink.

Recommend shut off valves be installed on the hot and cold water distribution lines under the kitchen sink.

Contact a qualified plumbing contractor.

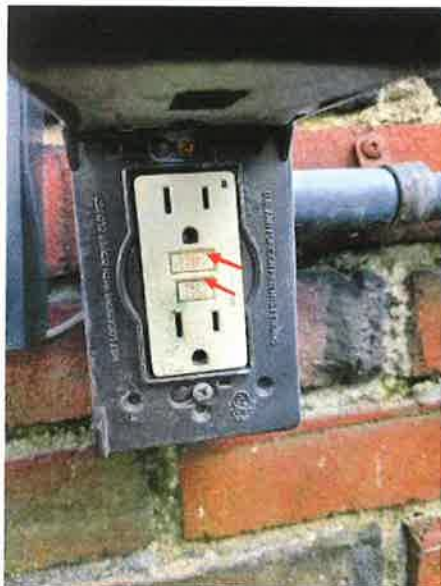
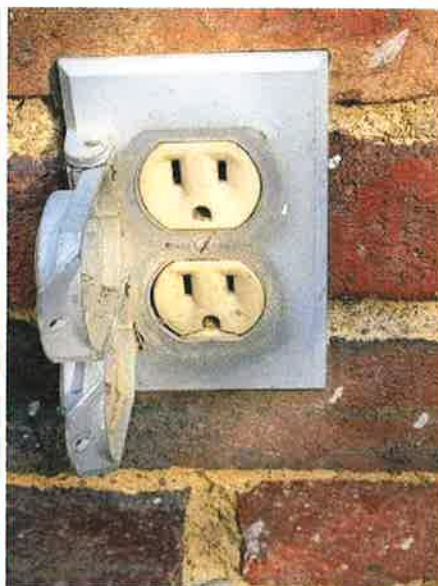
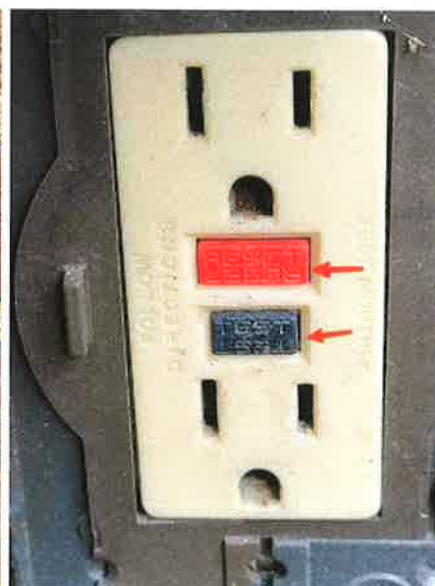
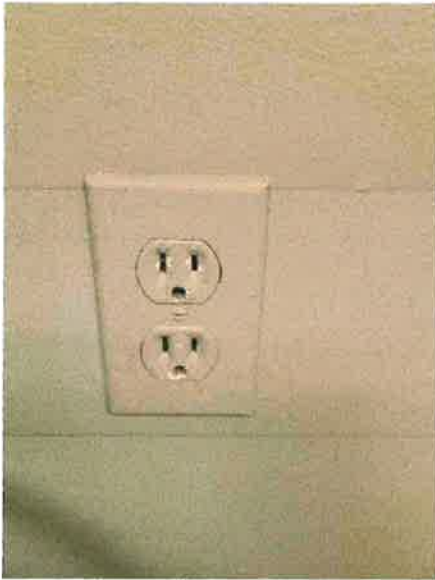
No GFCI protection present at the exterior receptacles; in the 2nd floor hallway bathroom and behind the clothes washer in the basement laundry area. Recommend licensed electrician upgrade by installing ground fault receptacles.

Recommend a licensed electrician install new GFCI receptacles.

Contact a qualified electrical contractor.

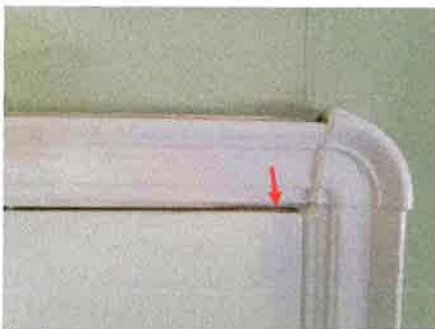
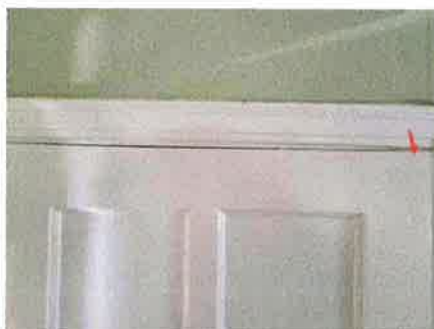
Bedroom

The door sticks in the 2nd floor bedroom that leads an adjacent bedroom at the top right and is tough to open Recommend sanding down offending sides.

Contact a qualified handyman.

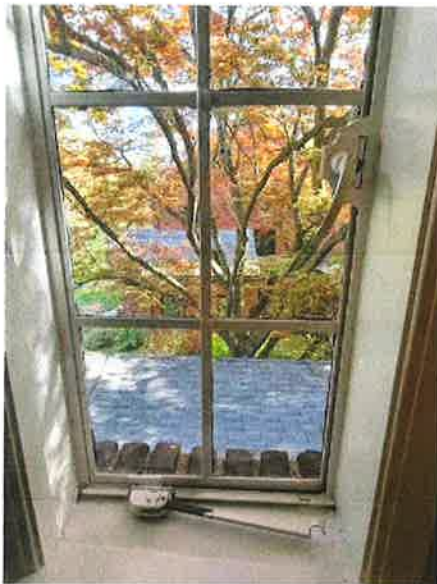
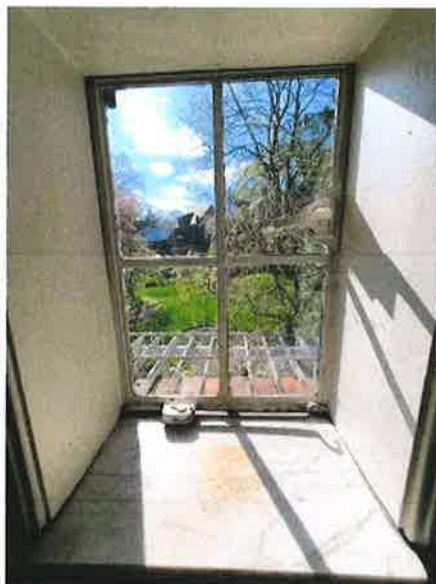
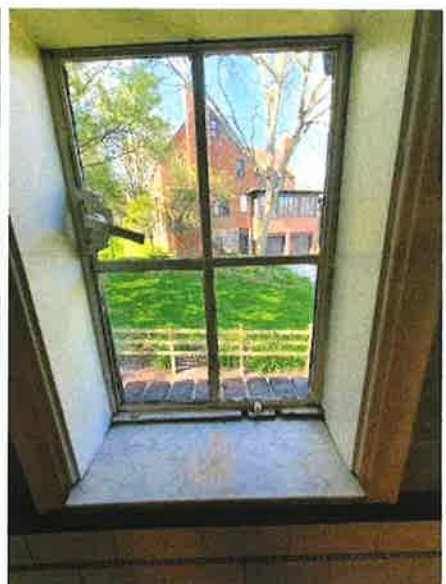
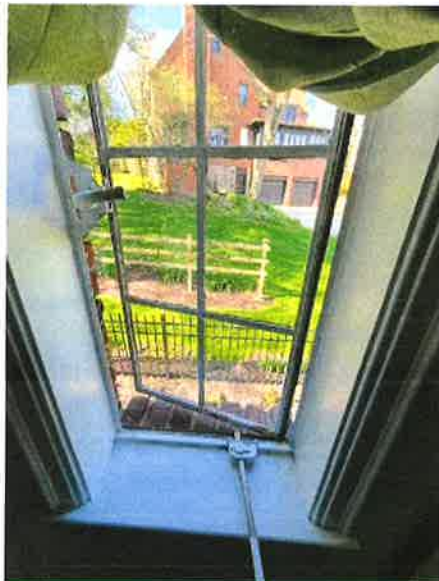
MISSING SCREEN

Window missing screen in the 2nd floor front bedroom, 2nd floor left rear bedroom and 2nd floor hallway bathroom. Recommend replacement.

Contact a qualified window repair/installation contractor.

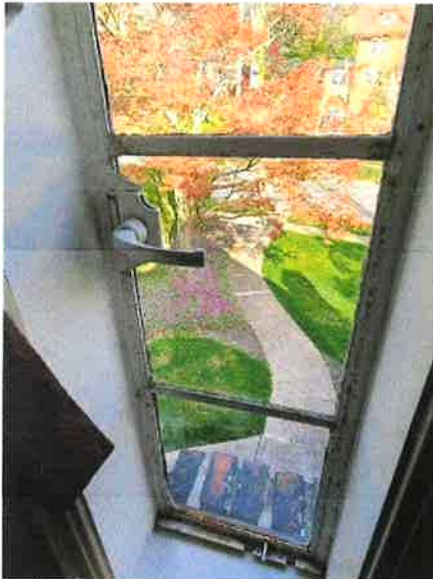
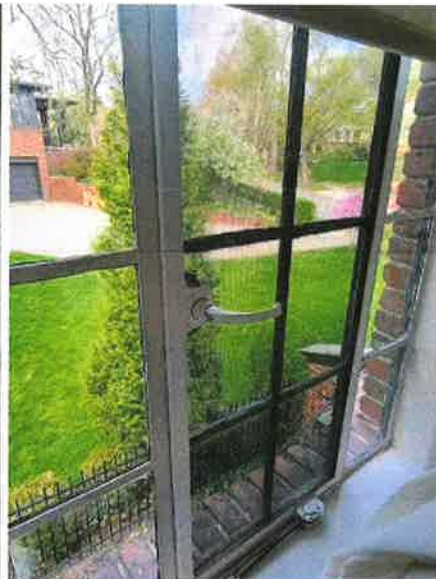
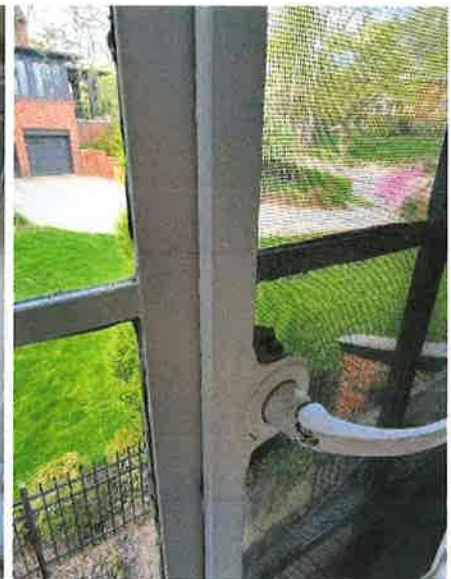
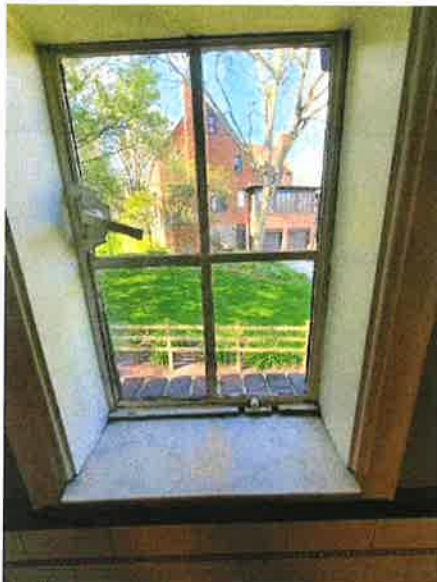
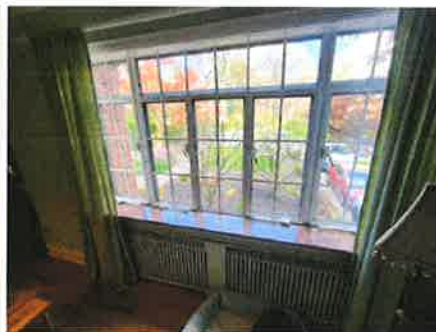
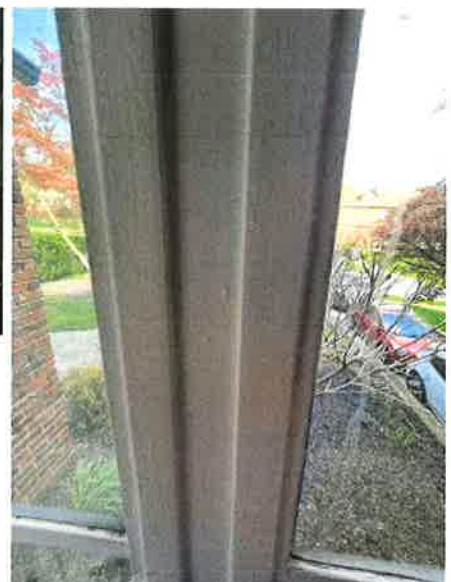
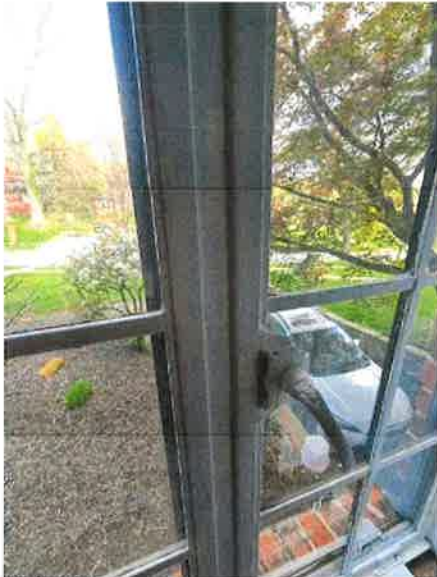
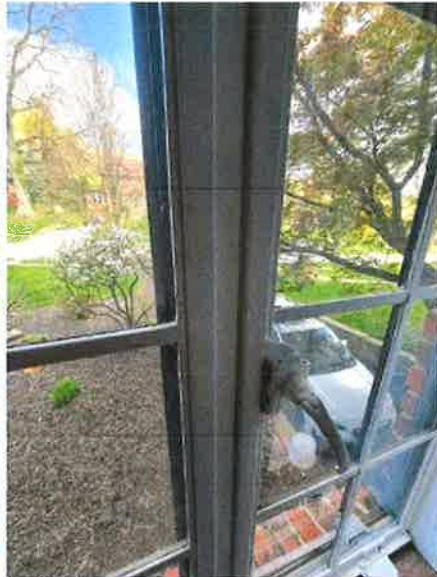
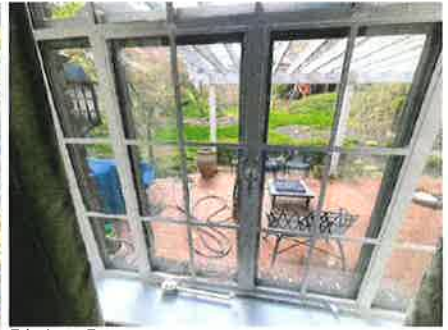
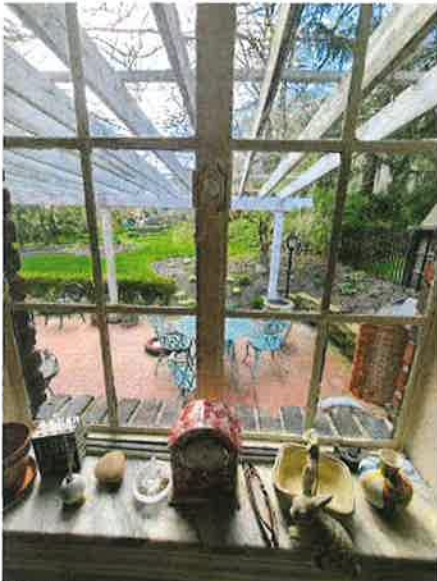
One or more windows are painted shut in the 2nd floor front right bedroom; 2nd floor hallway bathroom; living room; sitting room and kitchen. Recommend windows be restored to functional use.

Contact a qualified window repair/installation contractor.

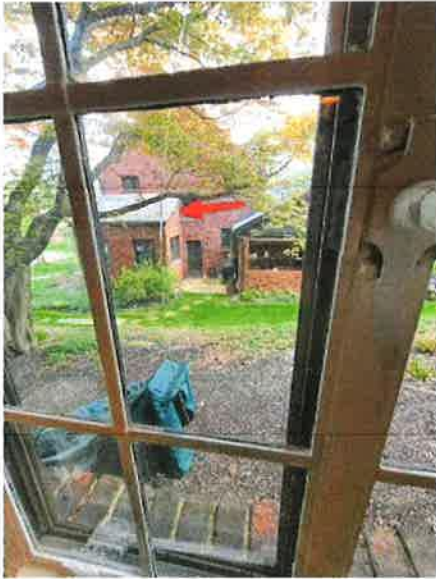
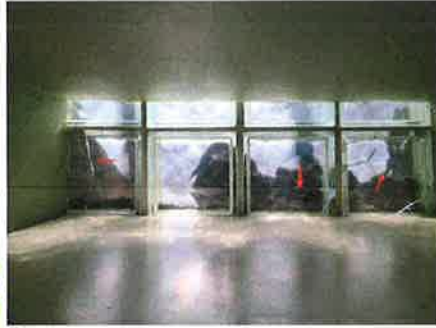
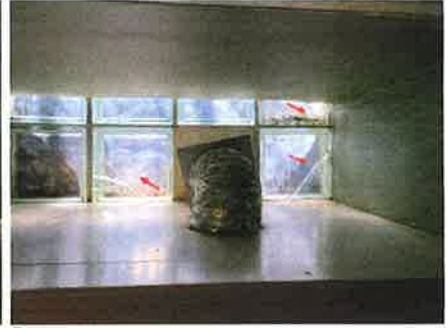
BROKEN WINDOW GLASS

There were 2 broken glass windows observed; one in the sitting room and two in the basement glass block windows.

Recommend a window professional replace the broken glass windows.

Contact a qualified window repair/installation contractor.

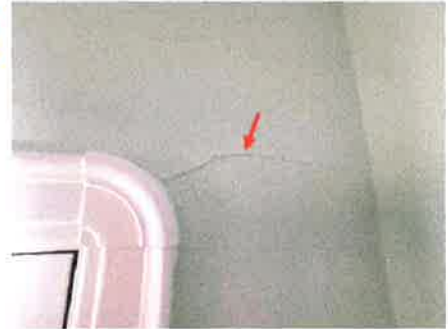
Living Room

MINOR CORNER CRACKS

Minor cracks at the corners of side porch door at the top right corner. Appeared to be the result of long-term settling. Some settling is not unusual in a home of this age and these cracks are not a structural concern.

Recommend a qualified professional patch and paint the cracked area.

Contact a qualified professional.

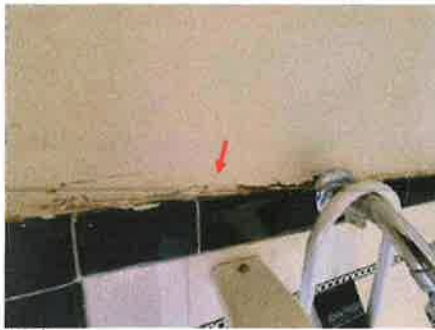
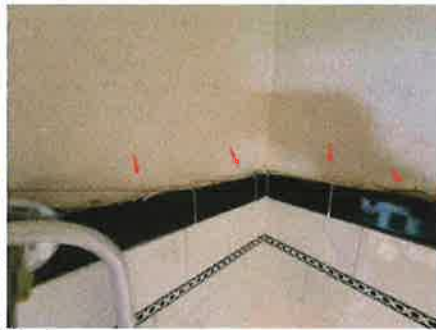
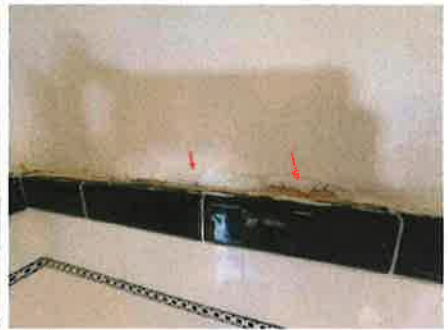
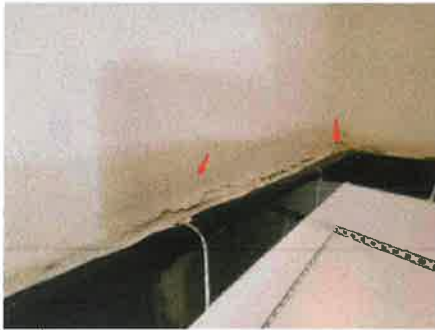
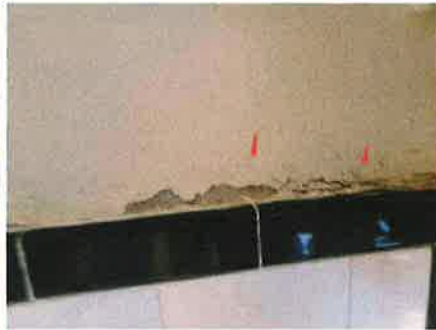
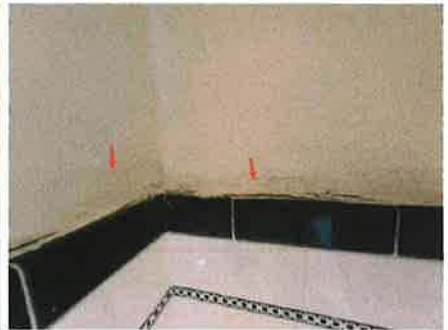
MOISTURE DAMAGE

Stains on the 2nd floor hallway bathroom walls above the tile in the shower visible at the time of the inspection appeared to be the result of moisture from the shower coupled with no fan and unable to open window due to it being painted shut.

Recommend a qualified professional repair the damaged plaster.

Recommend installation of a fan or have the painted windows unsealed.

Contact a qualified professional.

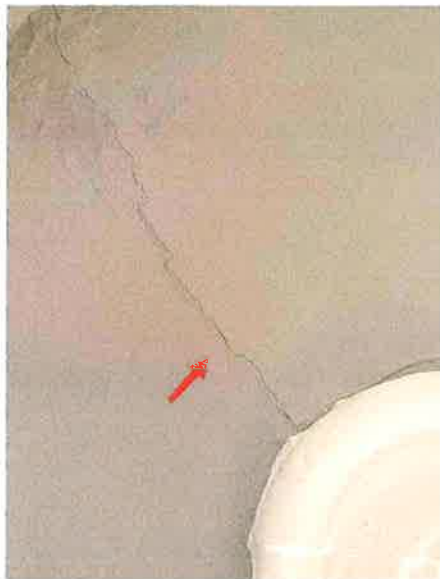
Bedroom

MINOR CEILING CRACKS

There were minor ceiling cracks in the 2nd floor front right bedroom left of the closet door and minor ceiling crack in the living room right of the front door.

Appeared to be the result of long-term settling. Some settling is not unusual in a home of this age and these cracks are not a structural concern.

Recommend a qualified professional patch and paint the cracked areas.

Contact a qualified professional.
